# FLOODING SOLUTIONS FLOODPLANK LABORATORY TESTING SEPTEMBER 2013

Report MHL2240  
October 2013

Flooding Solutions Advisory Group

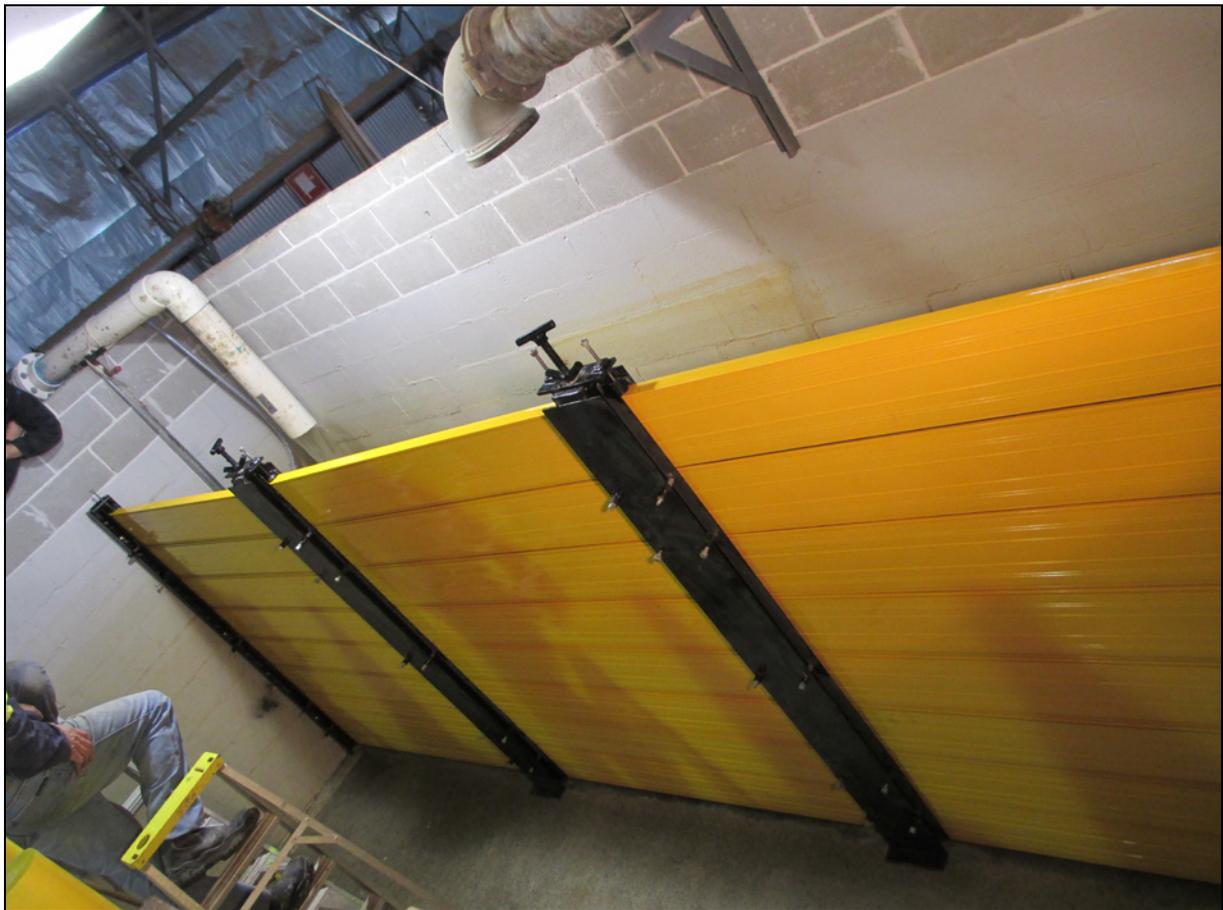
**Figure 1 Floodplank as Installed**

The test section comprised two wall connectors and two stanchions. The overall length of the test section was 5.430 m (see Figure 1).

The Floodplank system is a removable temporary floodwall, designed to offer similar performance characteristics to permanent flood barriers. Made from extruded aluminium, each Floodplank stacks on top of the previous plank, an operation that can be completed by a single individual. The Floodplank seals against flat floor surfaces. No sill is required, reducing the risk of trip hazards. Horizontal lengths to fit a particular opening width are made to measure. To provide continuous protection for larger openings or areas, multiple stacks of Floodplank can be joined together using support stanchions.

With the water level at 6.5 planks high (water level behind the system was 2.01 m) there was leakage of 11.6 litres in 30 minutes. Before this test was commenced, additional bracing was added to stop the tops of the stanchions from moving. In the normal Floodplank system there would be a 45° brace on the stanchion but there was not enough room in the test head box for this to be accommodated, hence additional bracing was added between the stanchion and the Floodplank.
